# The Excavation of WWII RAF Bomber, Halifax LV881-ZA-V

## ABSTRACT.

*This article outlines the preliminary results of archaeological fieldwork at the crash site of RAF Halifax bomber LV881-ZA-V and explores some of the challenges presented by the excavation of this military wartime crash site. The aircraft and her crew were shot down by a German night fighter in the early hours of March 31<sup>st</sup> 1944 during the infamous Nuremberg Raid. Four of her crew were killed and the remaining three were taken prisoner and later took part in the ‘Long March’. All three survived the war. An international team comprised of staff and students from Germany, the Netherlands, Finland and the UK explored what remained of the crash site, located on a hill outside the village of Steinheim, north east of Frankfurt in the German Federal State of Hesse.*

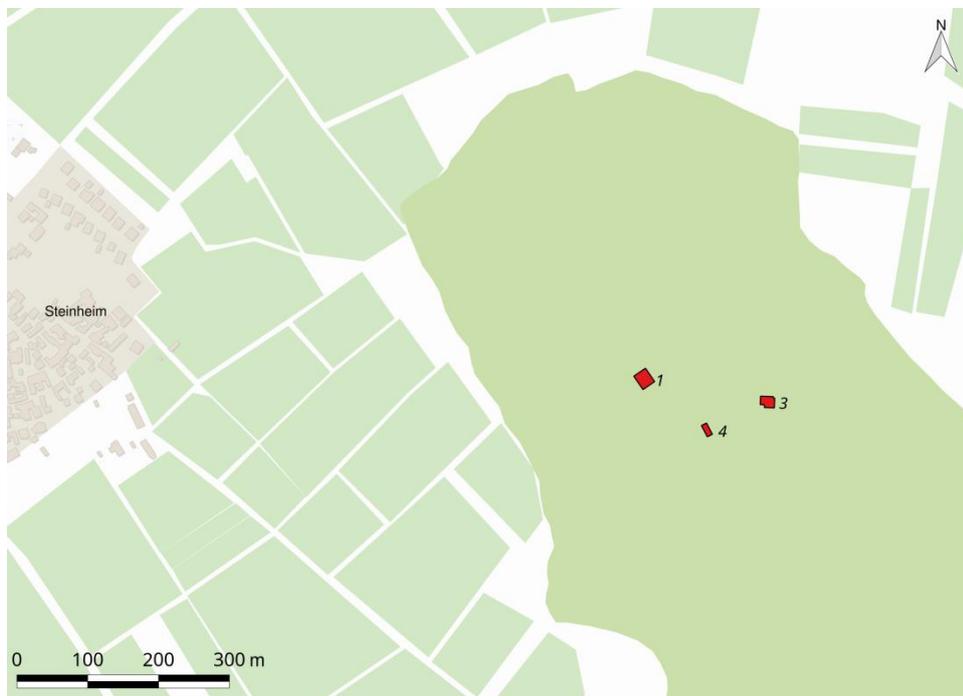
**Figure 4** Location of three trenches on the hill outside Steinheim. Trench 1 was designed to explore the cockpit location (in 2014), 3 the area of the main fuselage and 4 one of the engines (in 2015)(Source Topography © OpenStreetMap contributors).

material. As a result the excavation team decided to divide the chosen area into a series of 2m x2m grid squares that eventually encompassed an area that measured 20m x 23m (1 row of squares measured 2m x 1m). Each 2m grid square was numbered and excavated, with recovered objects being placed into corresponding labelled containers. In this way even very small items could be recovered and analysed and a distribution of the material created. Excavation usually proceeded to a depth of no more than 20cm, largely as a result of the proximity of the underlying bedrock to the surface and the lack of a single crash 'heavy impact point'. Indeed, all the material appeared to have been lying within the topsoil.

Excavation of a second area (Figure 4 Trench 3) closer to the top of the hill in 2015, revealed not only the previously mentioned fragment of uniform, but also a quantity of curved Perspex likely to have been from the Mid Upper turret. Nearby Trench 4 provided a confirmed location for one of the four Hercules radial engines. The parts that remained in situ, sat within a small impact crater made as the engine block drove its way into the hard bedrock.

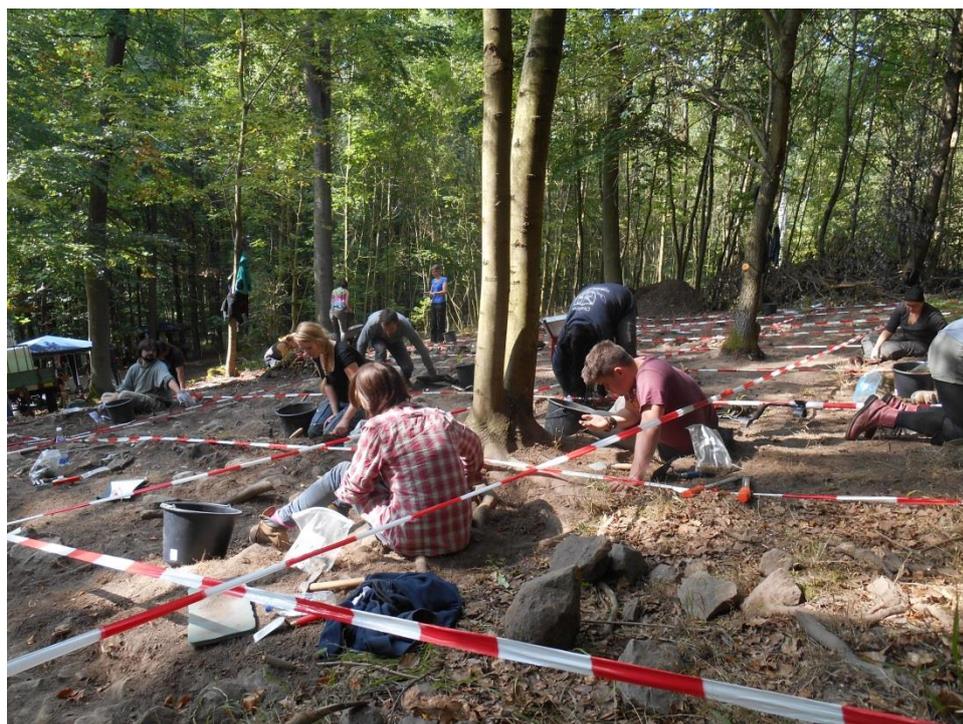
**Figure 5** Excavation at the site where the cockpit came to rest. Excavation grid-squares are divided up using 'emergency-tape' (Photo: Phil Marter).

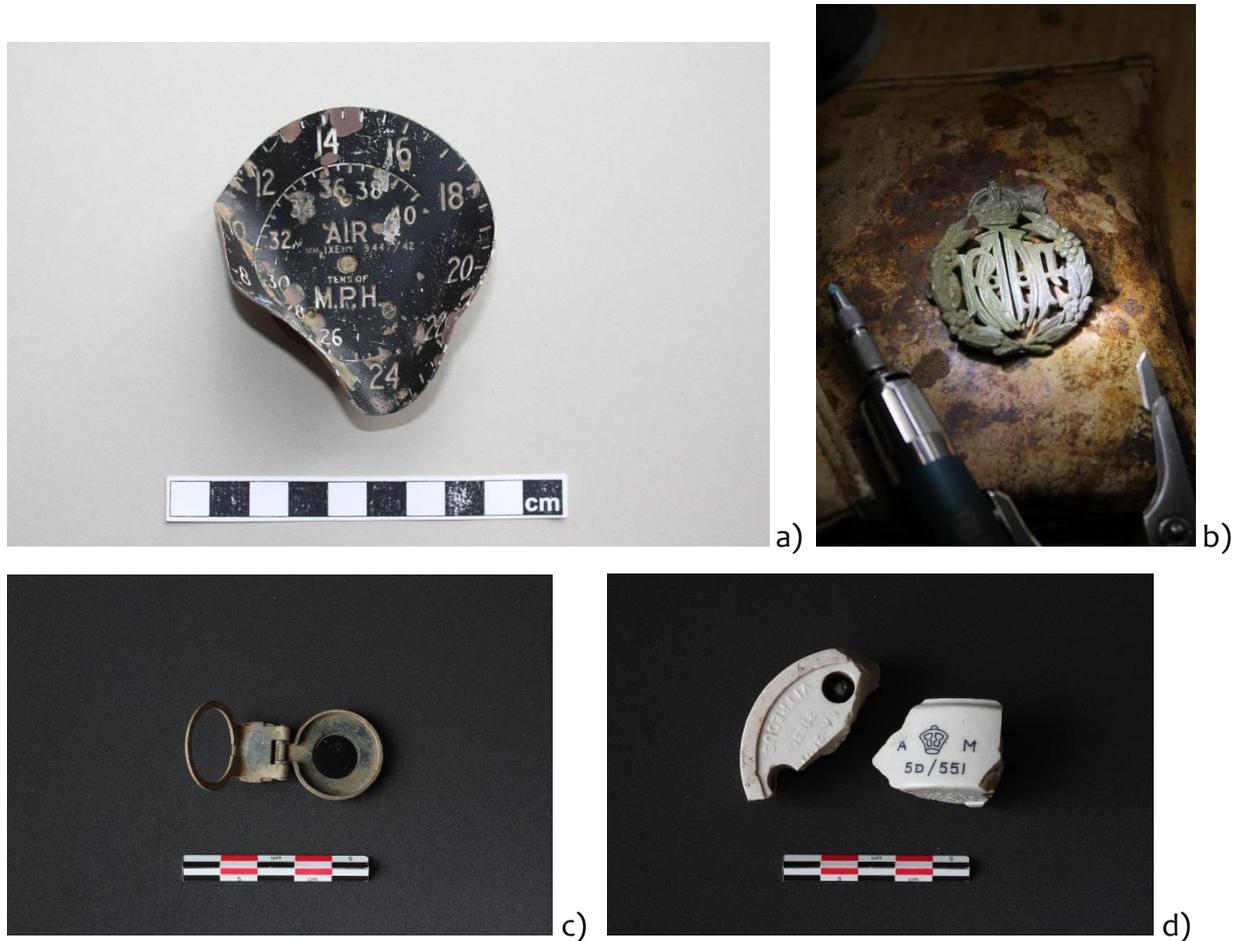
**Figure 6** Items from the crash site. The air-speed indicator a), forage cap badge belonging to Hugh Birch b), pocket compass c) and one of the many items displaying manufacturing serial numbers d) (Photos: hessenARCHÄOLOGIE).

Quite early on during the 2014 excavation (Trench 1, Figure 3) it was possible to identify that there was a clear concentration of finds in the centre of the excavated area. In some of the central squares more than 100 fragments per square were recovered in each. In contrast some of the outer squares provided little or no finds at all. This ability to define concentrations of material without locating each single object, proved to be a useful compromise that balanced information recovery with efficient time expenditure. It was a strategy that we continued to utilise in our second season of fieldwork. The sheer number of individual objects on site required a degree of pragmatism in relation to recovery and recording work. Whilst the large parts of the wreckage had already been salvaged in 1944, a huge variety of objects still remained on site, most were no larger than a few centimetres in size. These included numerous aluminium fragments of the outer shell of the plane, broken fragments of Perspex from the windows, parts of several appliances like the display of the Air Speed Indicator, the tachometer of one of the four engines and the display of one of the fuel tanks. A lens, probably from the MK XIV bomb sight used by Norman Wilmot or perhaps the on board camera, was also recovered. These items (see

Figure 6) all came from the cockpit area and the forward compartment, confirming that this had once been the location of a large section of the front of the aircraft (see Figure 7 for position of main elements of the aircraft).

Also amongst the finds were different levers, switches, lamps, cables, fuses, parts of the oxygen system and of one of the microphones. A large number of finds displayed part numbers, which helped the team identify which systems they had belonged to or even their place of production. Also very poignantly, the team recovered a number of the crew's personal belongings such as buttons from clothing, items from their flight suits, a pocket compass, a fragment of a comb and a pocket-knife. In the 2015 excavation (Figure 4, Trench 3 and 4) fragments of blue cloth, likely to be from one of the crew's uniforms was found. Of particular interest is a cap badge of the Royal Australian Air Force, found during survey work in 2014. There was only one member of the RAAF in the flight crew, so the badge certainly belonged to Mid Upper Gunner Hugh Birch who sadly lost his life during the crash. Hugh Birch was born in Bunbury (Western Australia) in 1923, and at the suggestion of the Australian Embassy in Germany, the team placed an advert hoping to trace the Birch family in the local newspaper *The Bunbury Mail*. Despite no longer living there, the family by chance saw the advert and the sister in law of Hugh Birch got in
